Appendix D - Photos

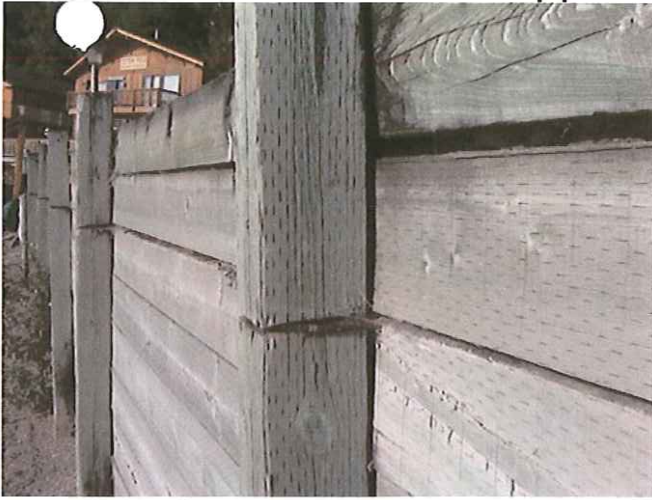
Current tie back

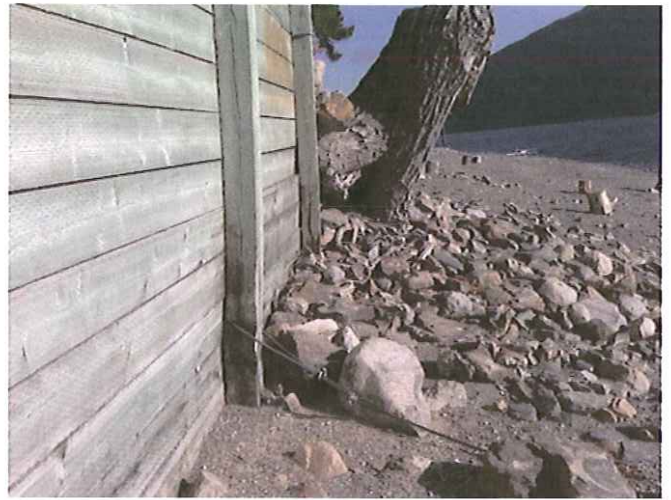
Existing cable anchor

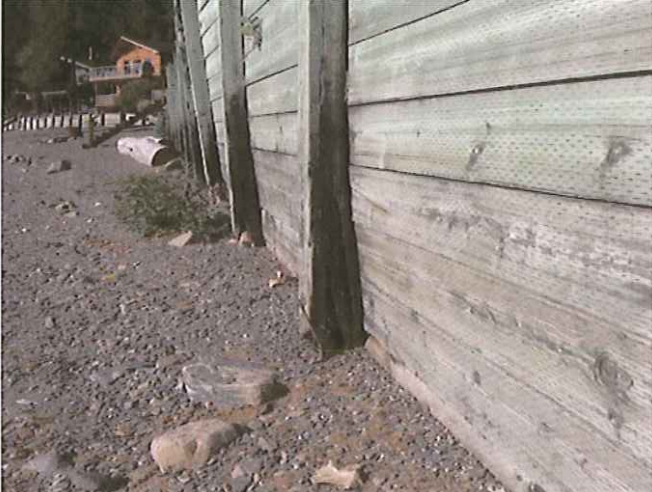
Existing post shear failure at toe

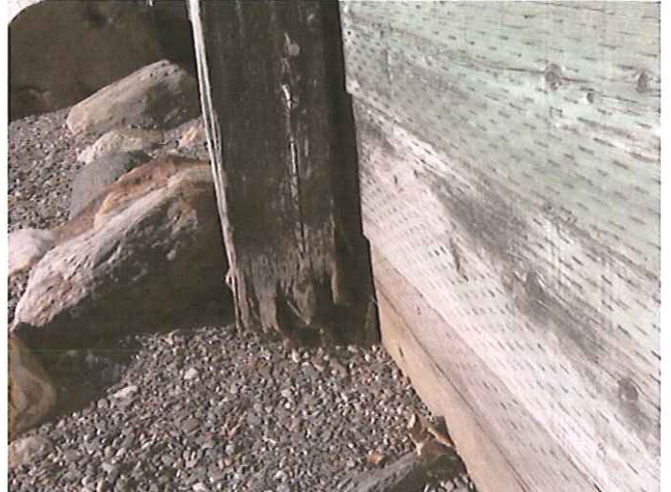
Rotted post
