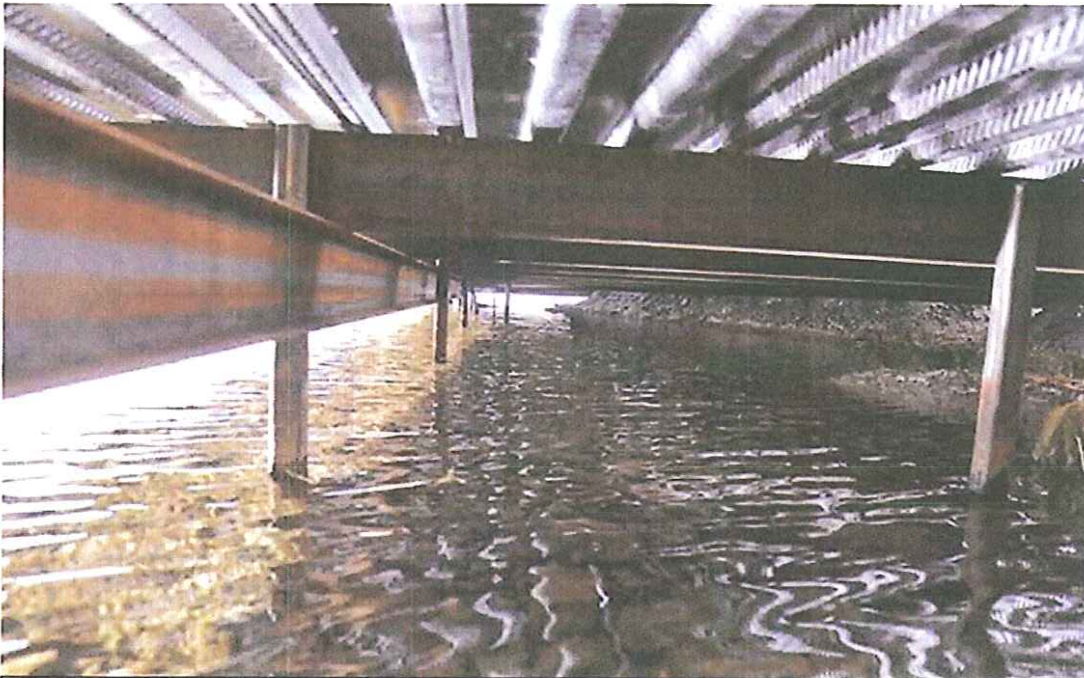
Photo E. View looking west from under the dock structure. There are no rooted aquatic plants under or near this dock that will be shaded by this structure. However a light-penetrating deck material would decrease the amount of shading to phytoplankton.

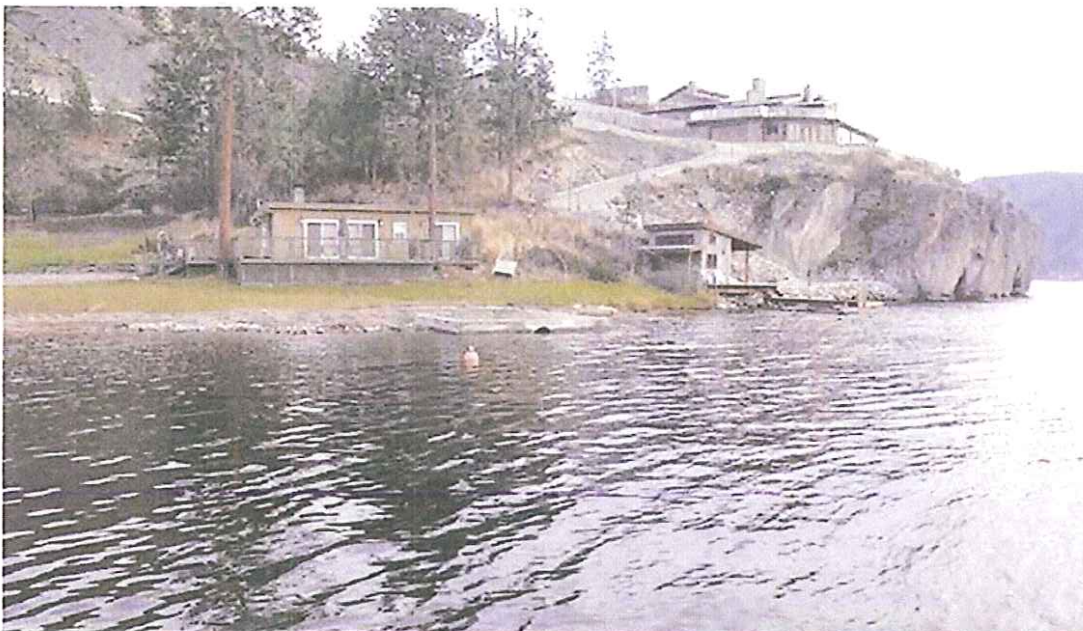
Photo F. View looking south west from the north property boundary along the dock. The foreshore area in front of the cabin and the area to the right of the cabin will be vegetated with 90 native species of plants to off-set the footprint of the proposed structure.

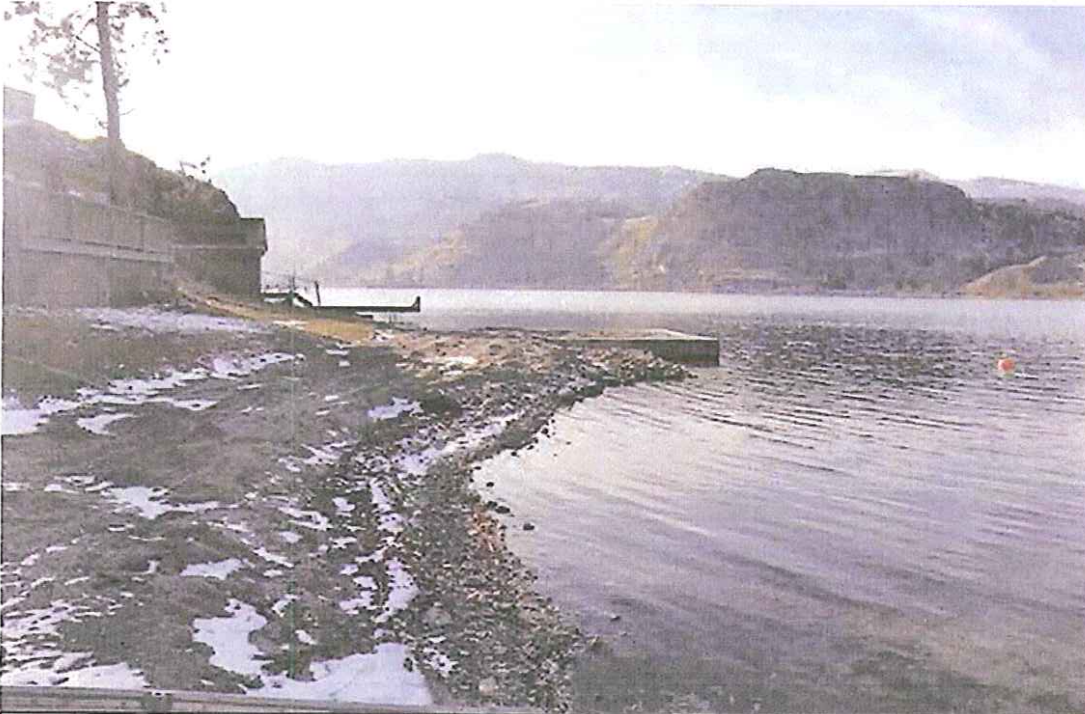
Photo C. View looking west from inside the cove. This area was disturbed recently to place a storm outfall drain from eastside road. This area should be restored and replanted with native grass, shrub and trees. Planting trees along the north shore of the cove has the added benefit of adding shade as well as leaf litter and insect drop to the lake. Insect drop is an important food item for fish.

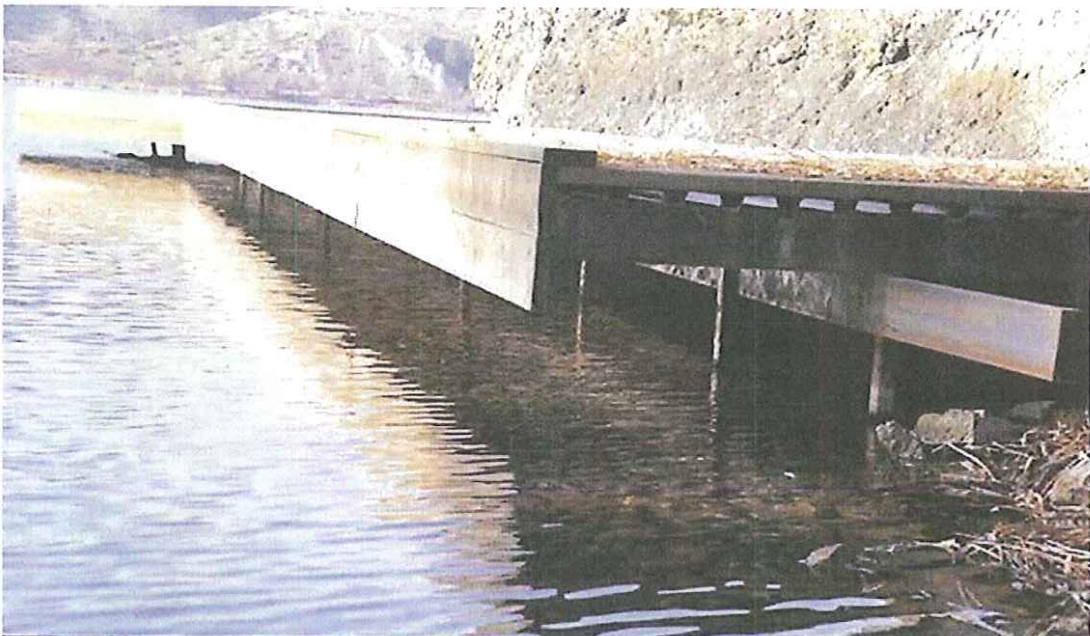
Photo D. View looking west from inside the cove. The lower batter board (2' x 8' skirting) and the lower metal 2' x 5' metal tube support beam both run the length of the dock and are both at high water of 338.0 m geodetic elevation. The board and the beam should be removed to allow for less shading and allow for a more natural wave action. The lower support structure should be 0.6 m above high water or 338.6 m. Currently the top of the deck is approximately 338.6 m.
