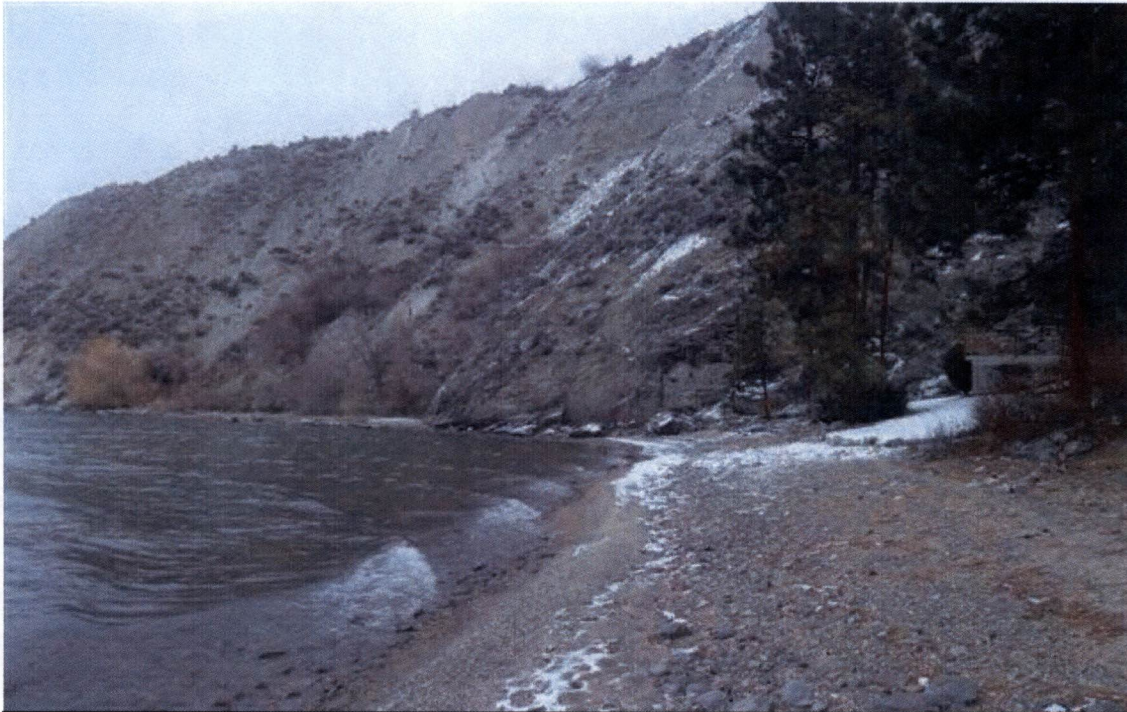
Photo 1) View looking north east at the glacial lacustrine bluffs found along the eastern shore line adjacent to the subject property. Most areas on the bluffs are covered by dry-land bunch grass species. Visible are big sedgebrush, nootka rose, rabbit brush and a ponderosa pine. Also visible is a small band of water birch / red-osier dogwood / rose plant community about 80 meters to the north east of the proposed dock but within the subject property limits. This ecosystem is a provincially red-listed plant community.

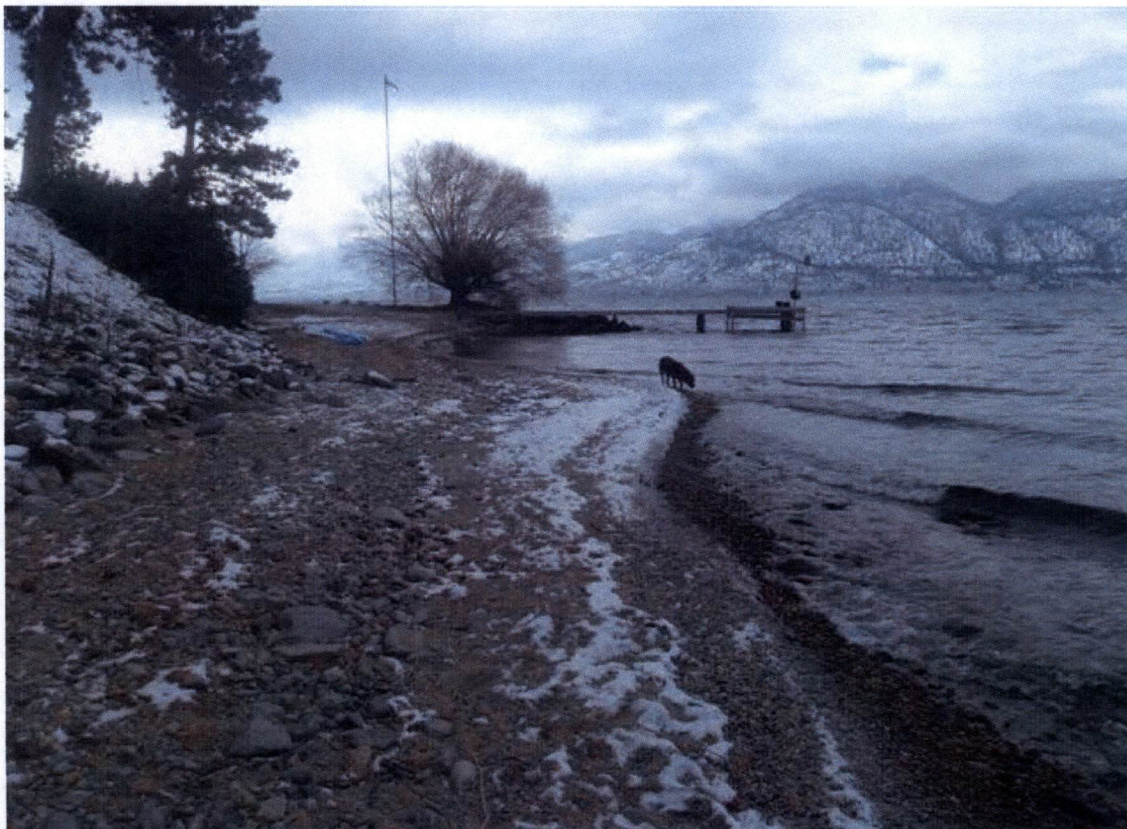
Photo 2) View looking south west along the high water of subject property. Visible is the existing non-conforming dock. Shoreline substrates consist of cobble / large-small gravel / sand.

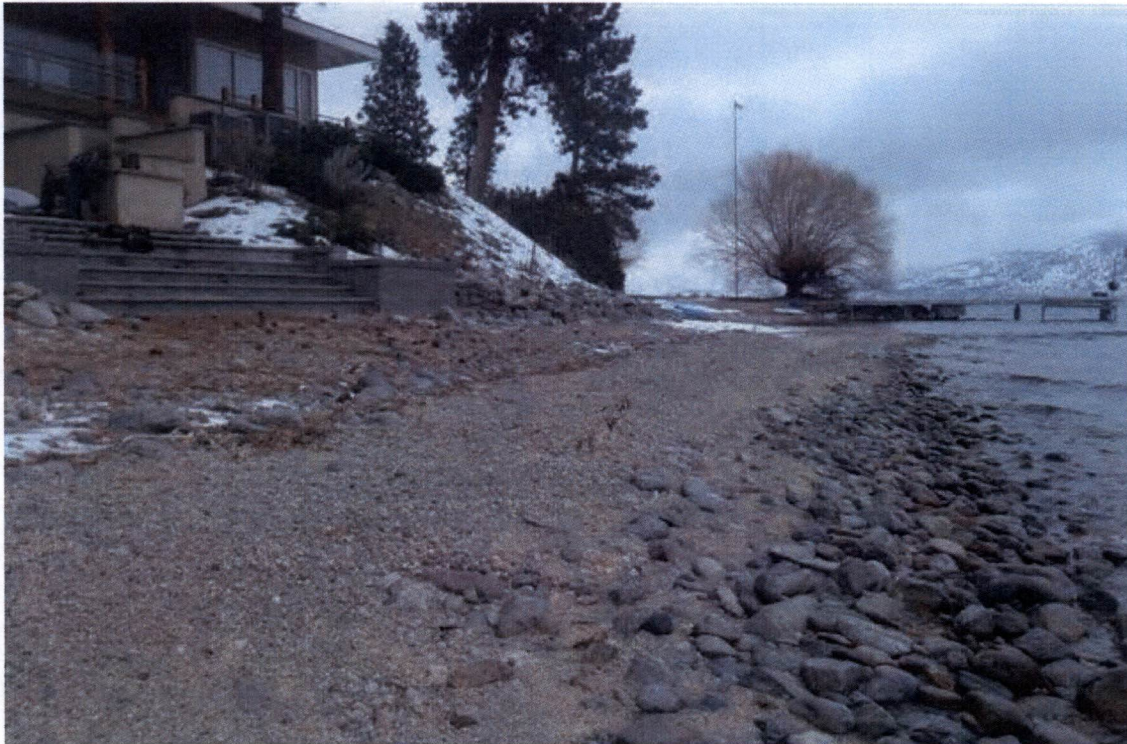
Photo 3) View looking south west at a stairway where the accessway for the dock will be located. Much of the foreshore and riparian areas have been extensively modified in the past. Most of the native shrubs and small woody trees/shrubs such as waterbirch and rose have been removed. Numerous ponderosa pines can be found within the riparian area. Remaining native understory shrubs consists of dogwood and Oregon grape. No riparian or aquatic vegetation will be removed during the construction of the dock.

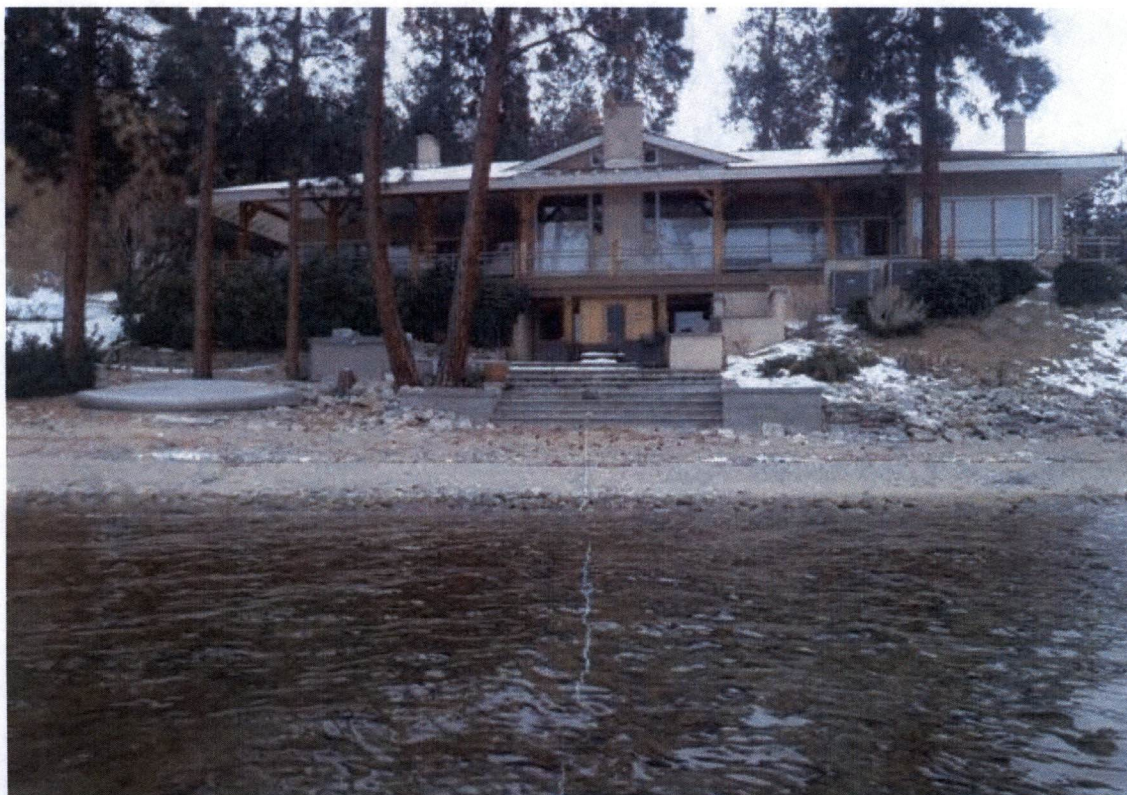
Photo 4) View looking south at the location of the proposed dock. Much of the shoreline along the property has been modified. Visible are the remaining ponderosa pine. There will be no removal of native plant species for the proposed dock.

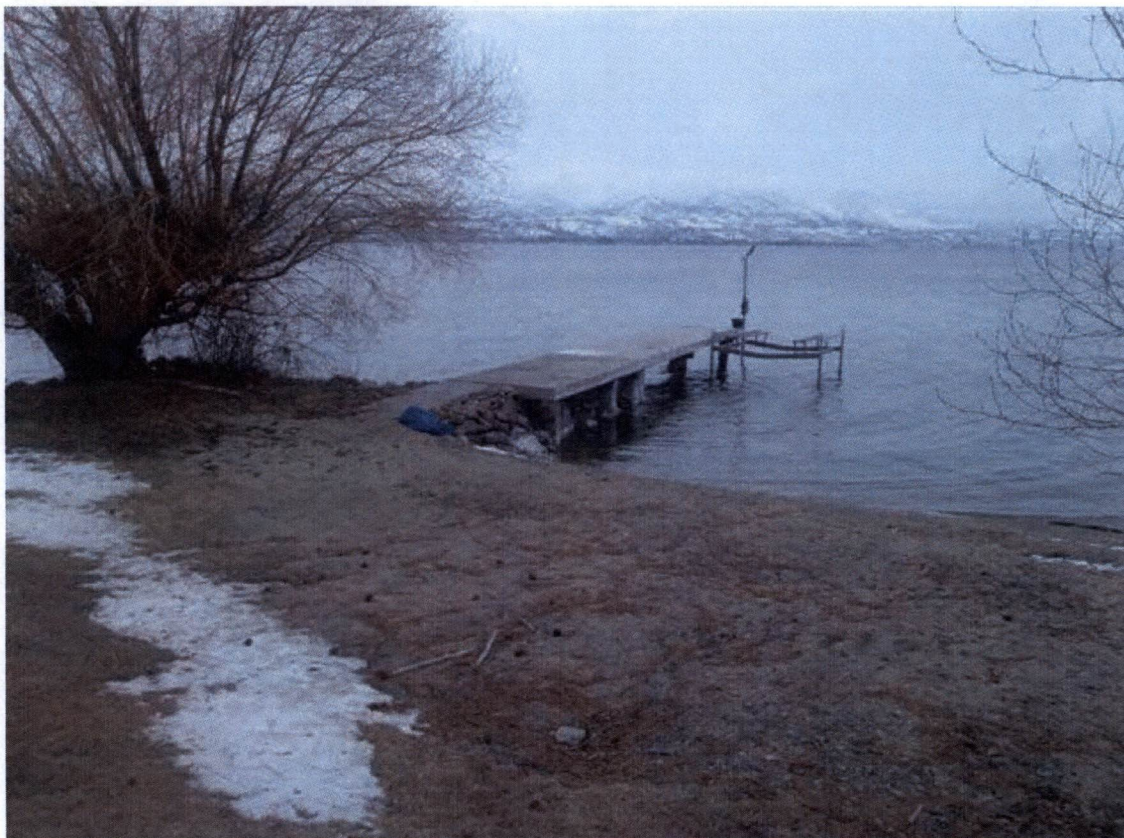
Photo 5) View looking north at the existing dock. This does not conform to the existing provincial guidelines and will be removed. The walkway is greater than 1.5 m and the depth of water at the end of the dock is < 0.8 m at low water. A floating silt curtain will be used when removing the existing pilings as this has the highest potential for sedimentation disturbance.
