February 9, 2015

Re: Reservoir fillslope sign off.

Road section identification: Battani Creek reservoir fillslope.

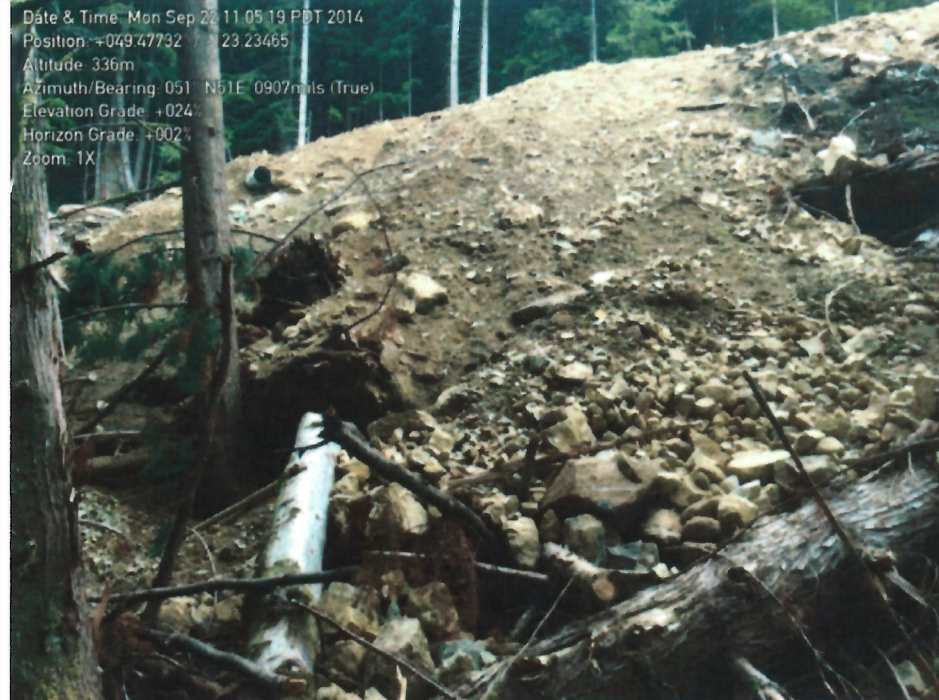
Photo 1. Fillslope before work initiated.

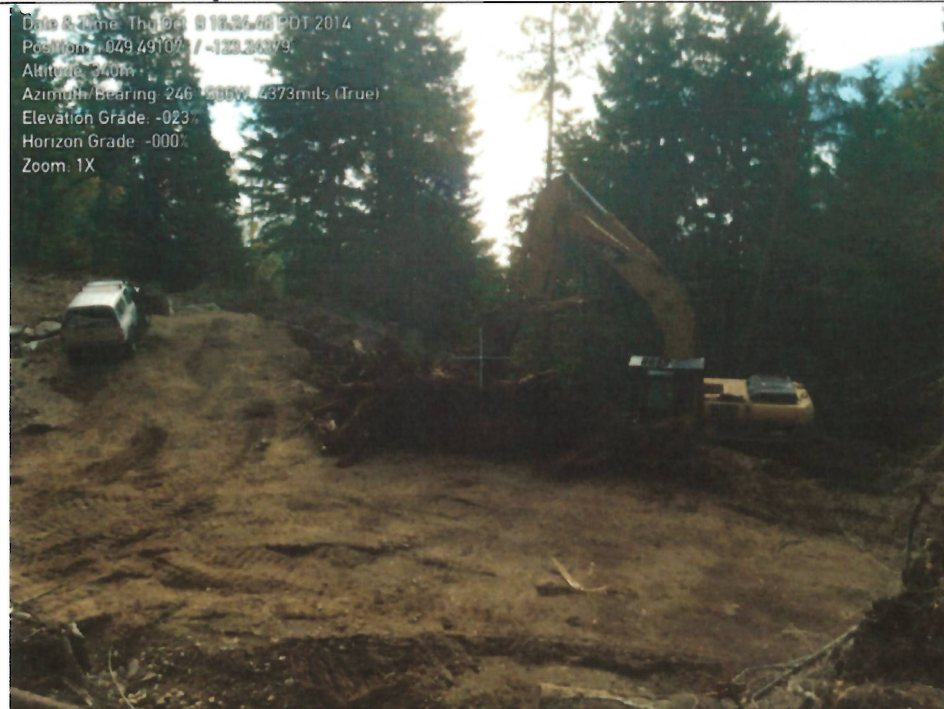
Photo 2. Wood removed from fillslope during deactivation.

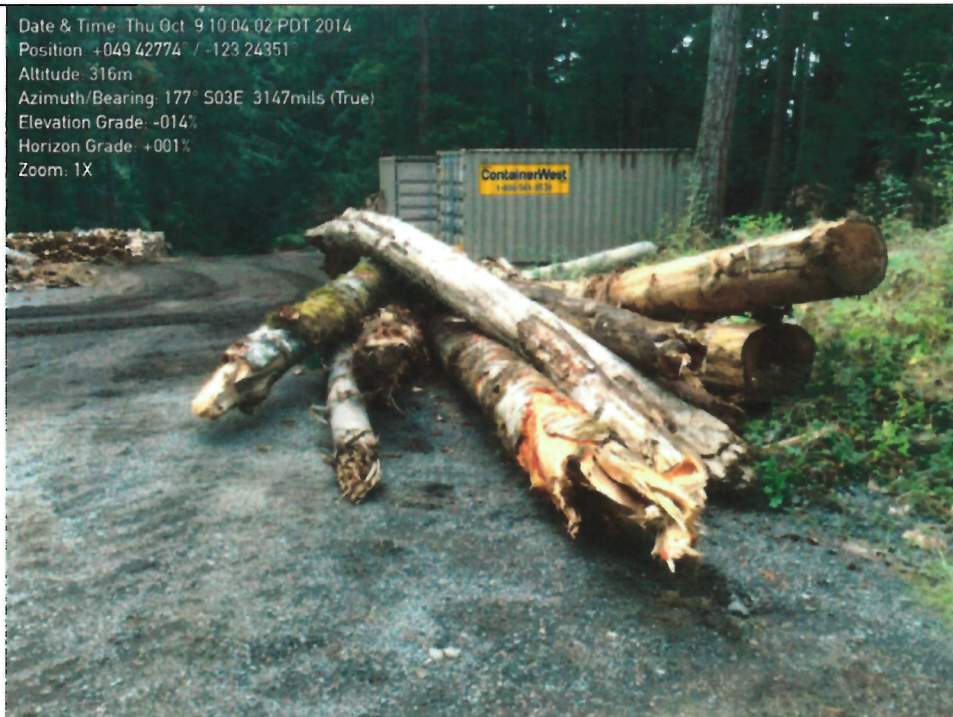
Photo 3. Logs removed from fillslope toe and endhauled to junction.

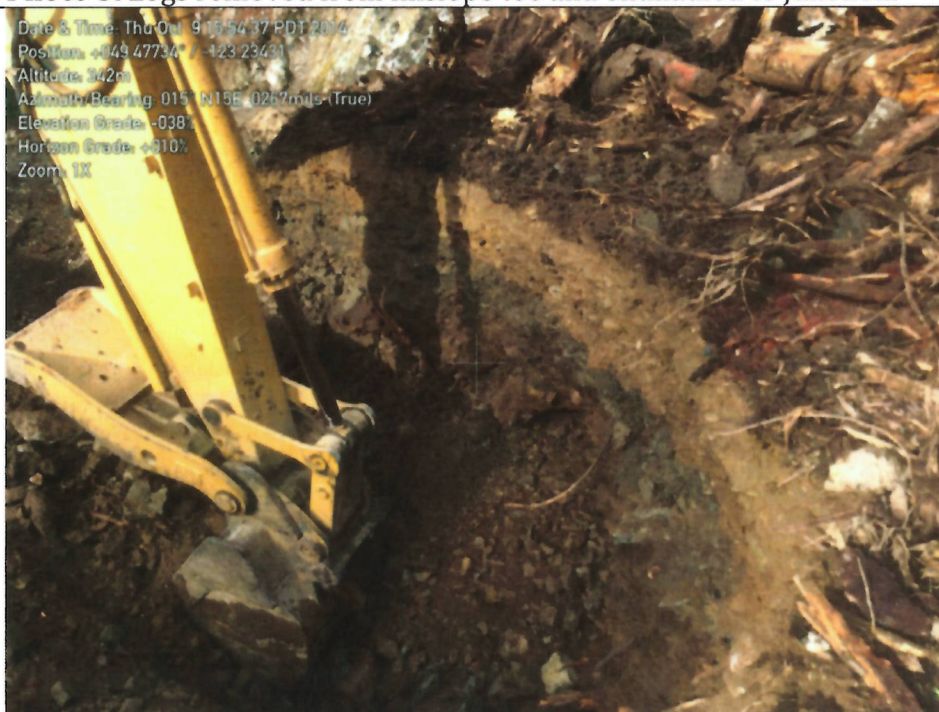
Photo 4. Layers of buried fill in fillslope.

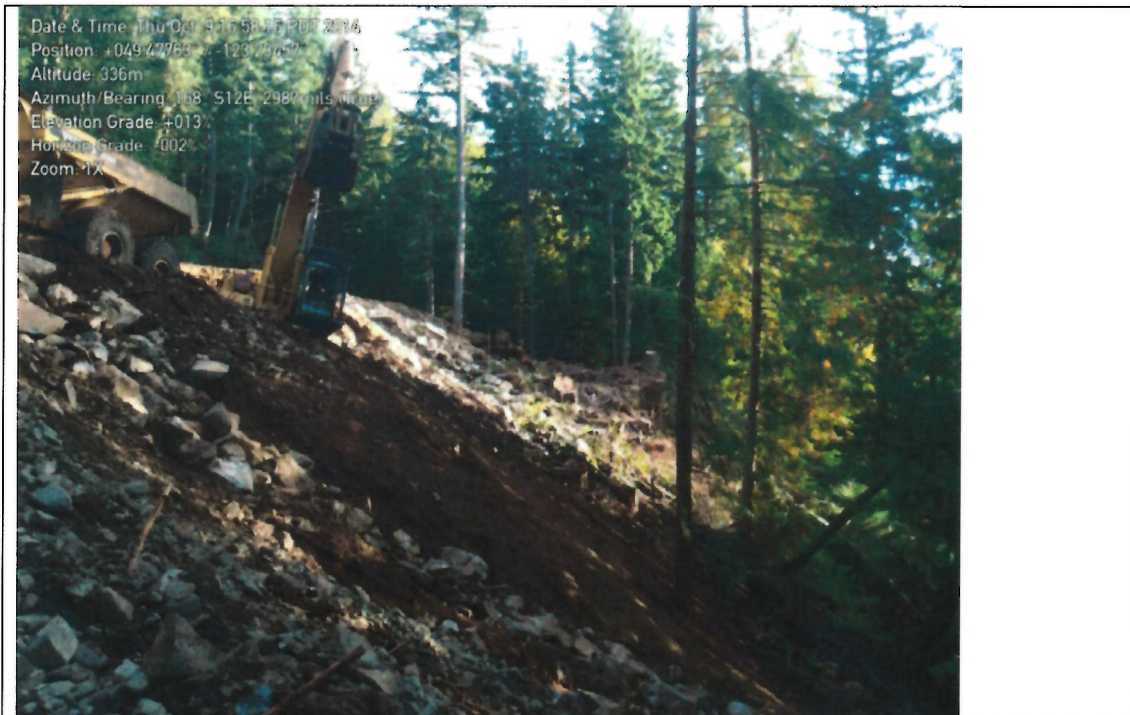
Photo 5. Deactivation by afternoon of October 9, 2014. Benching down to get fill.

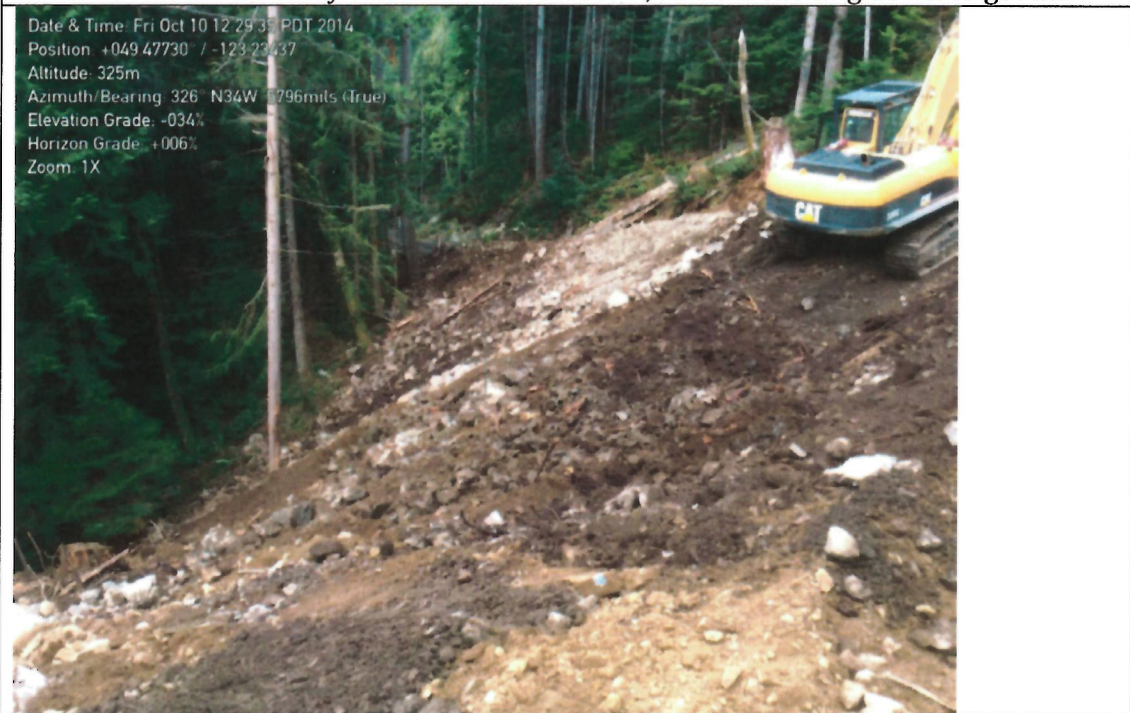
Photo 6. Deactivation by afternoon of October 10, 2014.
