Qualified Professional Checklist for Foreshore Works - Okanagan LLP

Project Name: **New Dock at #2 12877 Kidston Road, Coldstream, BC**

Date: March 27, 2016

Project Summary: Construct 29 m long new dock with 18 untreated wood piles and untreated wood timbers and decking.

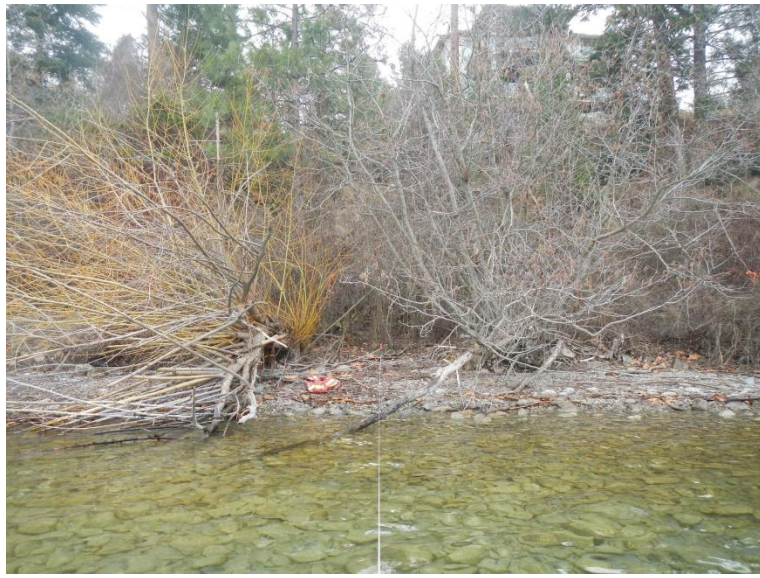
Photo 1.
Looking toward shore showing
existing riparian vegetation.
Mar 4/16

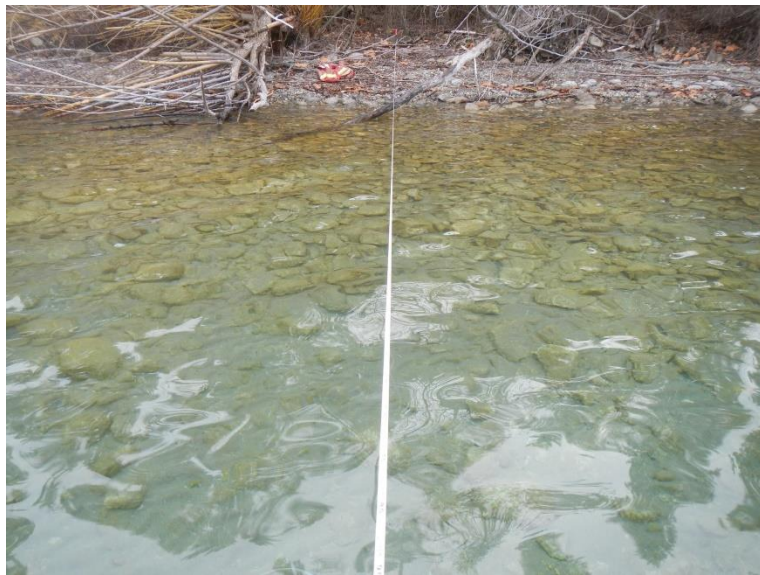
1.4	evaluated and described local soil and foreshore substrate?	X			substrate was gravel and cobble over sand, low shore spawning potential (Photo 2)
1.5	assessed potential changes to local shoreline and stream mouth accretion/erosion dynamics? <i>(only required for marina, infill and erosion protection works)</i>			X	not a marina, infill, or erosion protection works

Photo 2.
Typical substrate of gravel and
cobble on bed of sand.
Mar 4/16

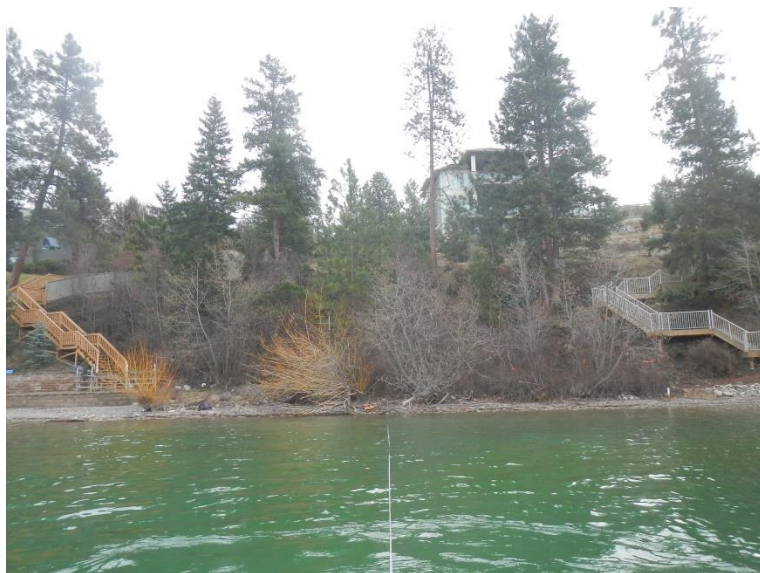
Photo 3.
Looking toward shore (approx.
east) along proposed dock
alignment.
Mar 4/16

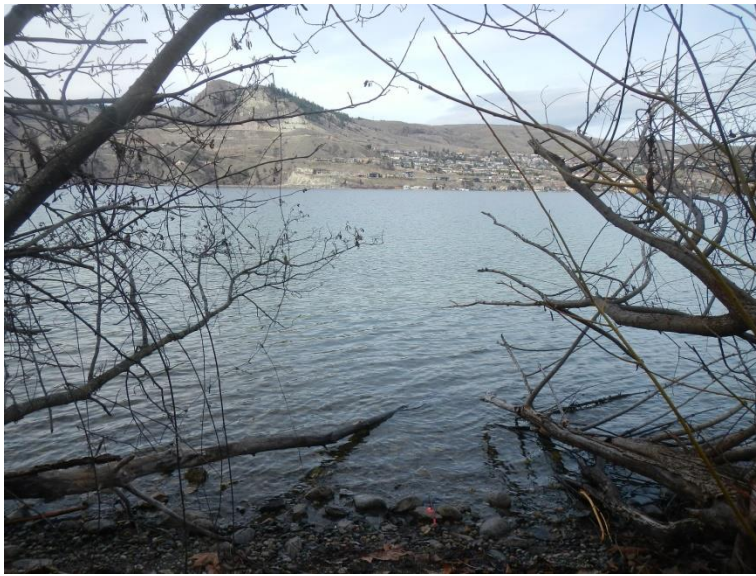
Photo 4.

Looking out from shore (approx. west) in vicinity of proposed dock alignment.

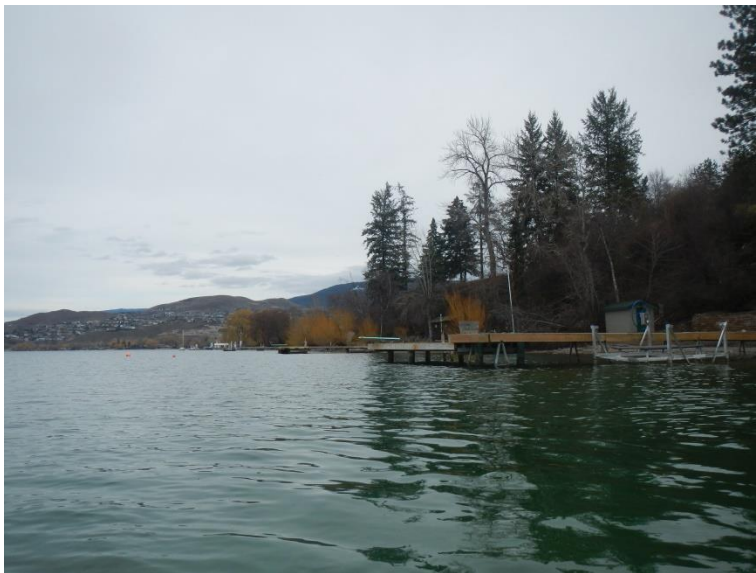
Photo 5.

2.7	minimized the footprint of the works?	X			18 wood piles
2.8	considered one common lakeshore access on multiple lot sites?			X	site is single lot
2.9	maintained a 50 m lakeshore frontage between moorage structures on single lots?		X		docks on adjacent lots north and south ~20 m away (Photo 5, Photo 6)

Shoreline development looking north.

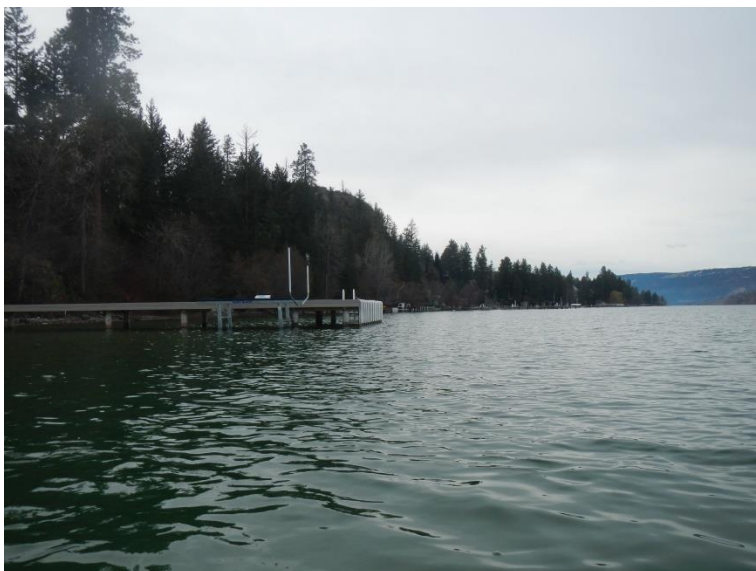
Photo 6.

Shoreline development looking south.
