Appendix B Photos

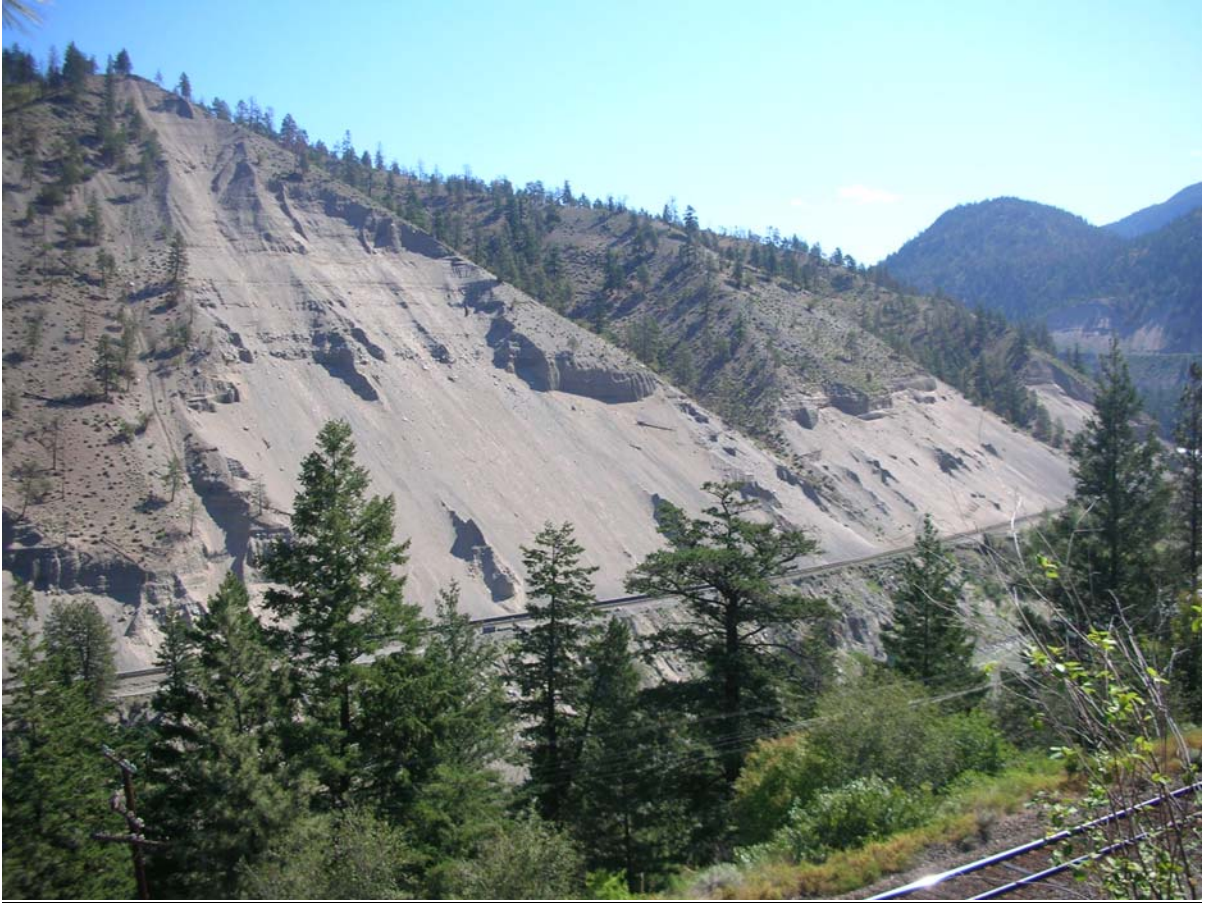
Photo 1

View from Hwy 1 facing northeast showing main terrace. CP Rail tracks in foreground.. CN Rail trackson opposite side of the river at base of gravel slope. Aggregate resource ends on bedrock just beyond the third cut face.

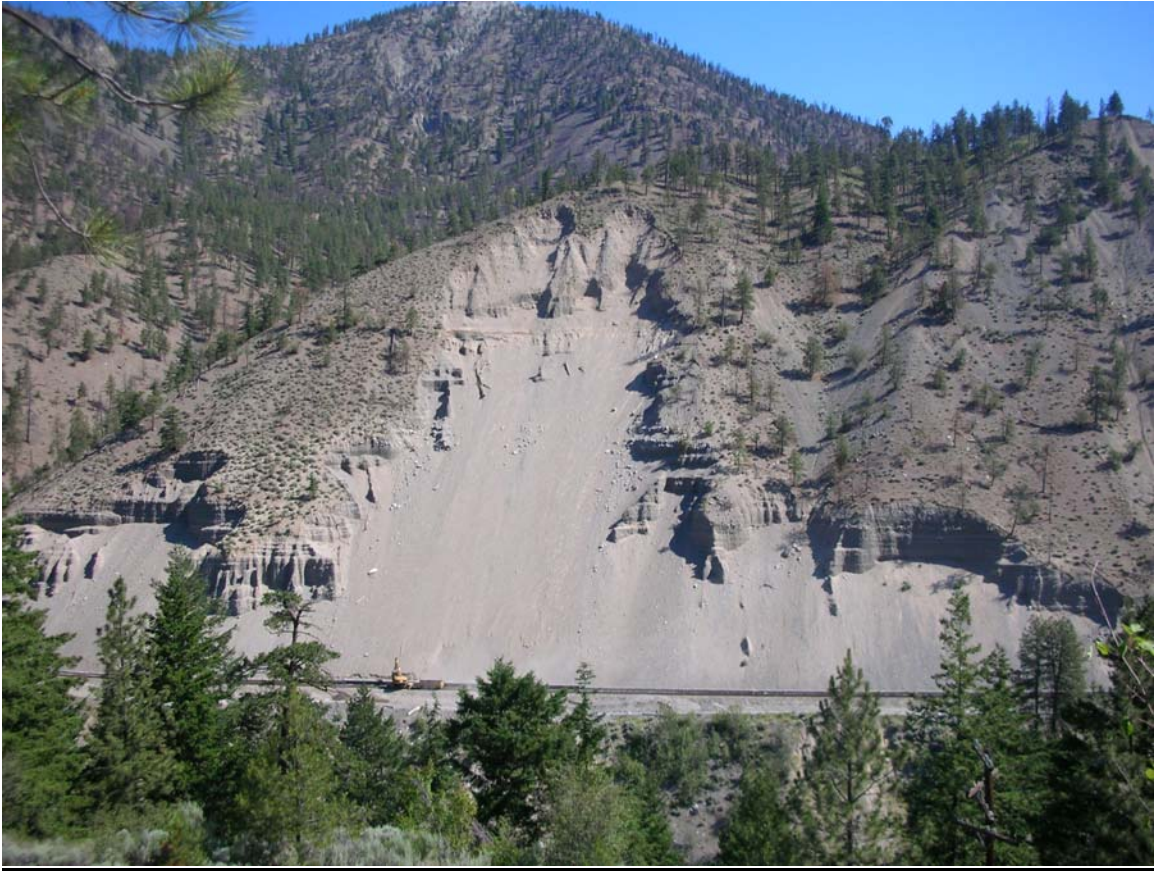
Photo 2

Main face of deposit showing top of terrace. Bedrock outcrop is on ridge in background. CN Rail tracks in foreground

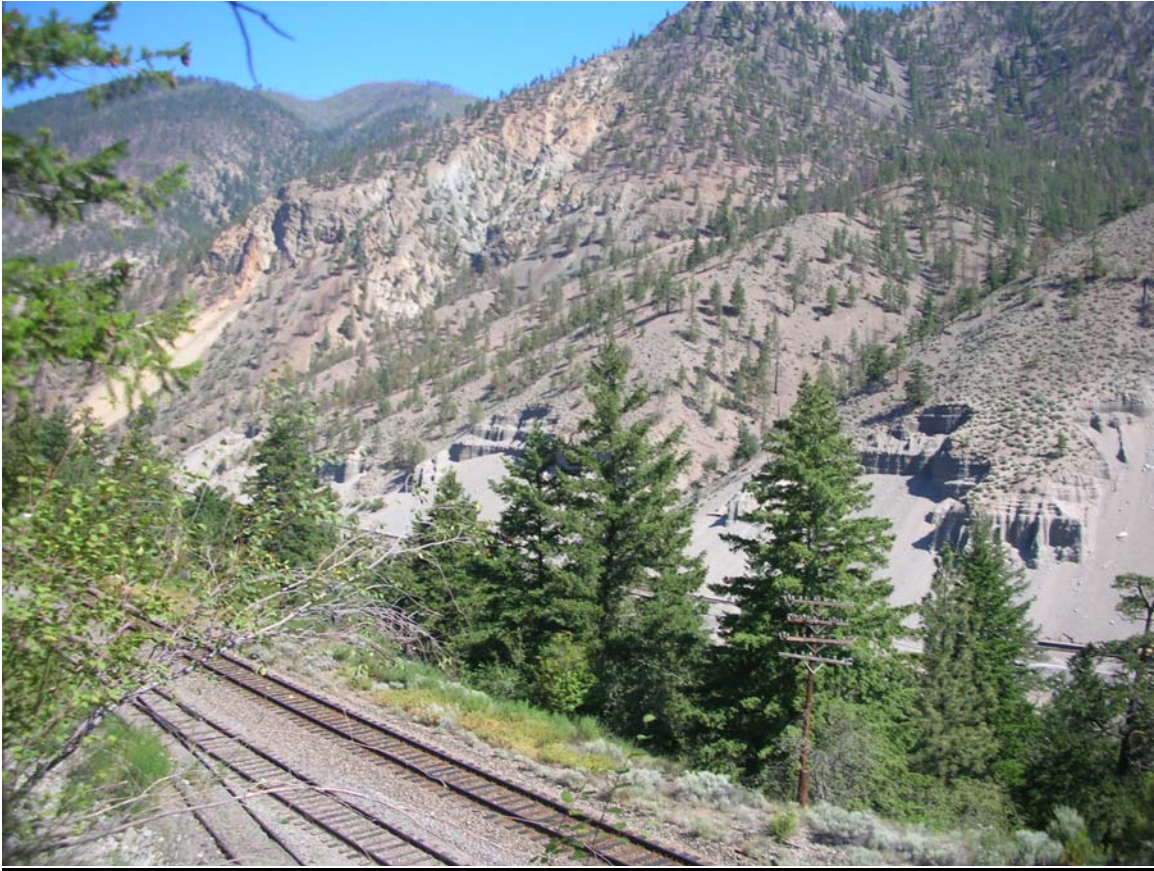
Photo 3

View from CP tracks facing northwest showing the western extent of the aggregate terrace. Bedrock evident on ridge in background.
