Re: **Lot C, Sec. 29, Tp. 23, ODYD, Plan KAP91304, 3274 Shayler Road, Kelowna, BC –
Environmental Assessment of Proposed Dock**

As requested, the following environmental assessment of a dock proposed on Okanagan Lake off of Shayler Road in Kelowna, BC has been revised to reflect a changed dock design.

Project Name: **New Dock at 3274 Shayler Road, Kelowna, BC**

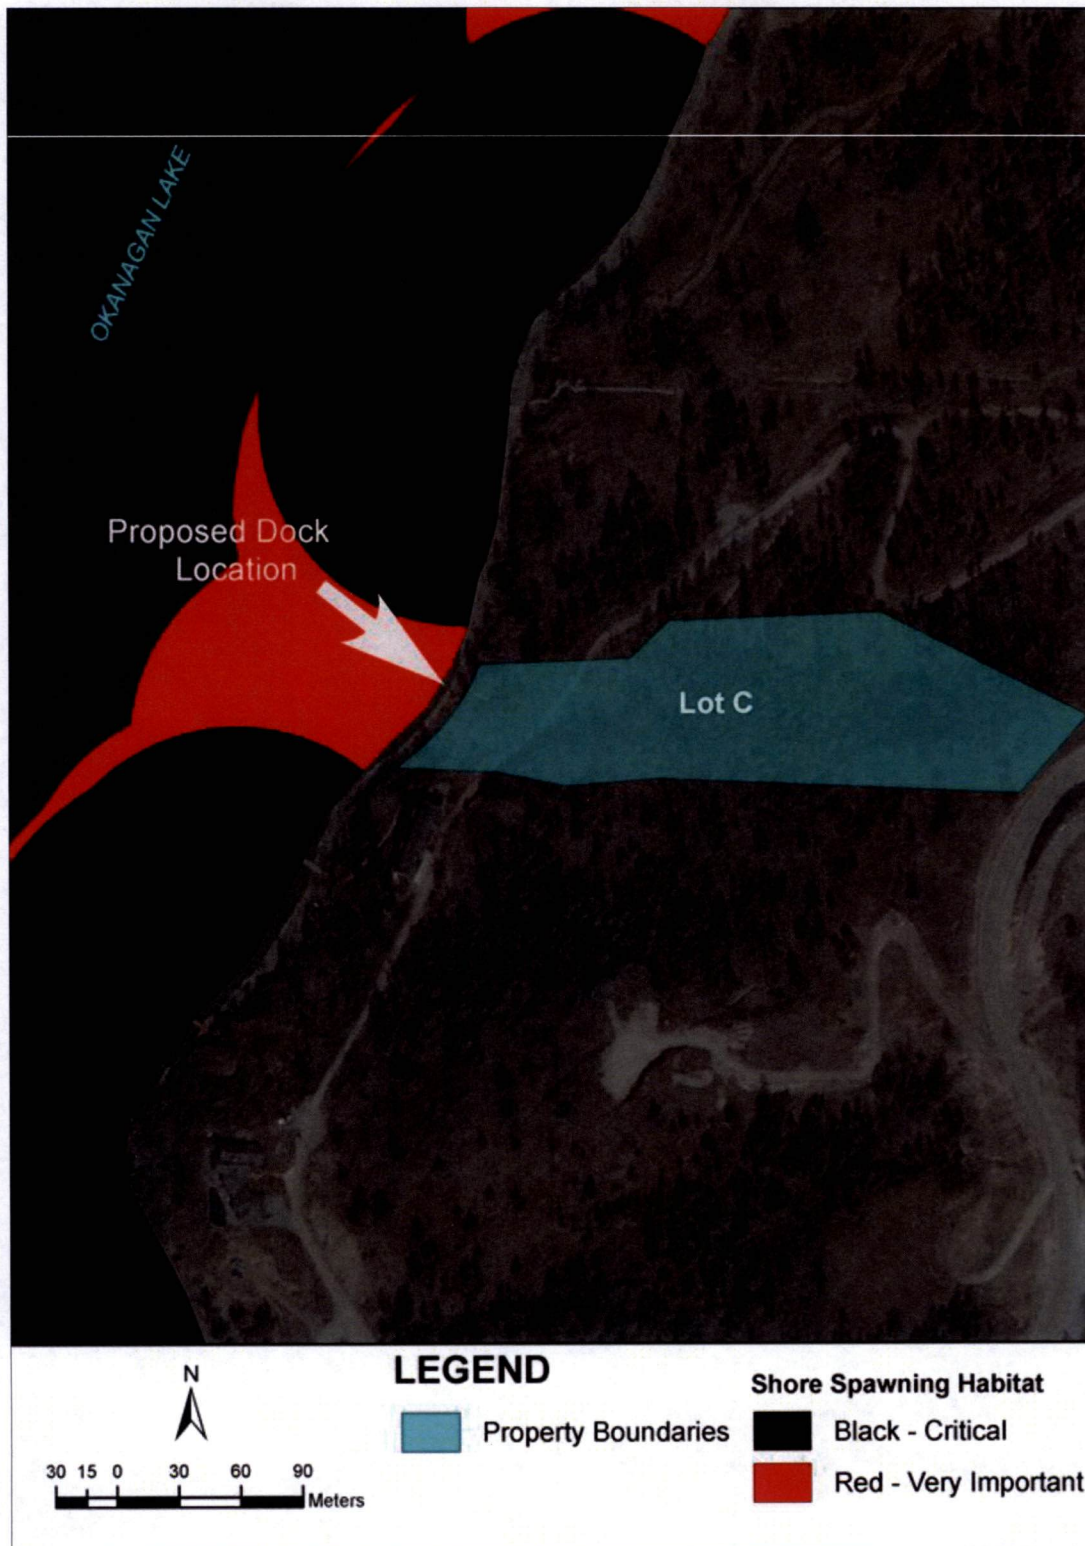
Figure 2. Location of proposed dock at Lot C 3274 Shayler Road, Kelowna, BC, in relation to habitat colour zones.

The proposed dock location is in a narrow band of red zone between adjacent black zones (Figure 2). The red zone along the shoreline is bound by UTM coordinates 324271 m E 5539590 m N on the north side and 324216 m E 5539519 m N on the south side. Coordinates of the proposed dock origin are 324262 E 5539562 N.

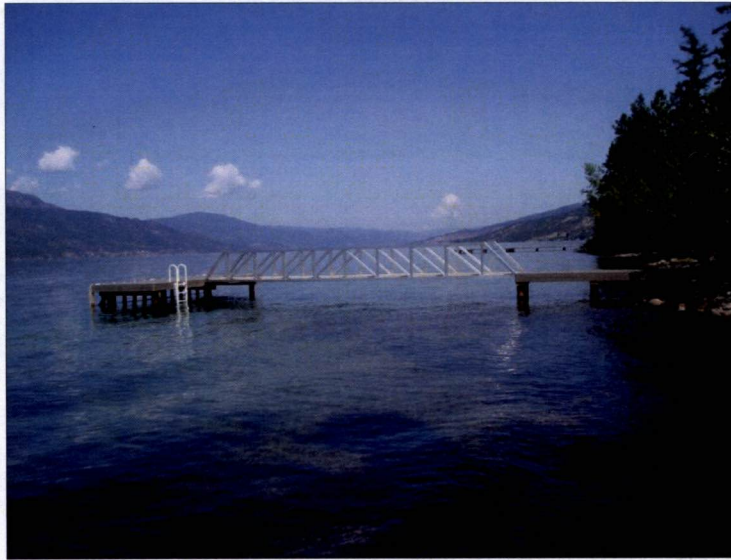
A dock on the adjacent lot to the north (3270 Shayler Road) with a similar aluminum bridge over the spawning habitat is shown in Photo 1.

Looking north at a dock with
bridge similar to that proposed for
Lot C 3274 Shayler Road,
Kelowna, BC.

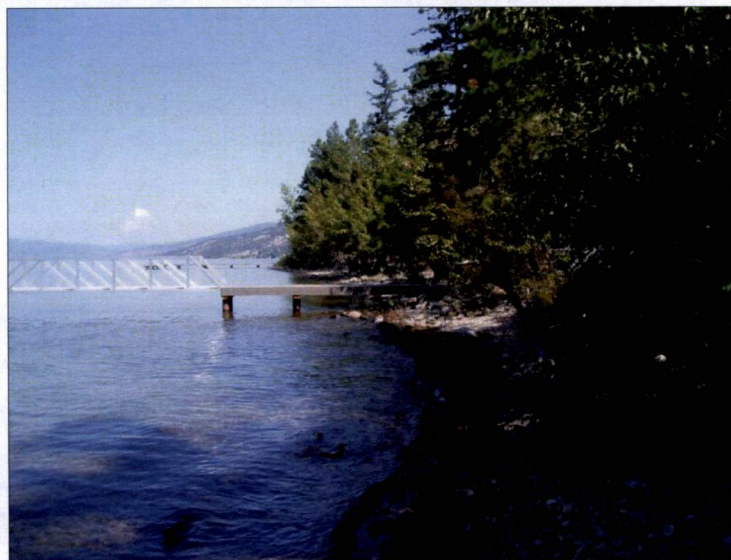
The dock location is on a relatively undeveloped shoreline (Photos 1, 2) of rounded, broken rock, with a shoal sloping at 11-12% to a dropoff into deeper water around 25 m out from HWM (Figure 3). Depth measurements are provided in Appendix 2. Lake-bottom substrate is broken or sub-angular rock out to the 341.6 m elevation, then rounded cobble 7-20 cm in diameter (Photo 3) between 341.6 m and 340.4 m, transitioning to larger cobble and boulder up to 45 cm diameter resting on sand out to 338.3 m and mainly sand beyond that. No aquatic vegetation was observed.

Riparian vegetation at the dock site consists primarily of black cottonwood (*Populus trichocarpa*) saplings, with other species including Ponderosa pine (*Pinus ponderosa*), Douglas-fir (*Pseudotsuga menziesii*), Saskatoon (*Amelanchier alnifolia*), and Oregon grape (*Mahonia aquifolium*) (Photos 1, 2, 5). There is vegetation typical of the Ponderosa pine-Bunchgrass BEC (Biogeoclimatic Ecosystem Classification) Zone on the adjacent hillside (Photo 5).

Looking north along shoreline
from proposed dock location.

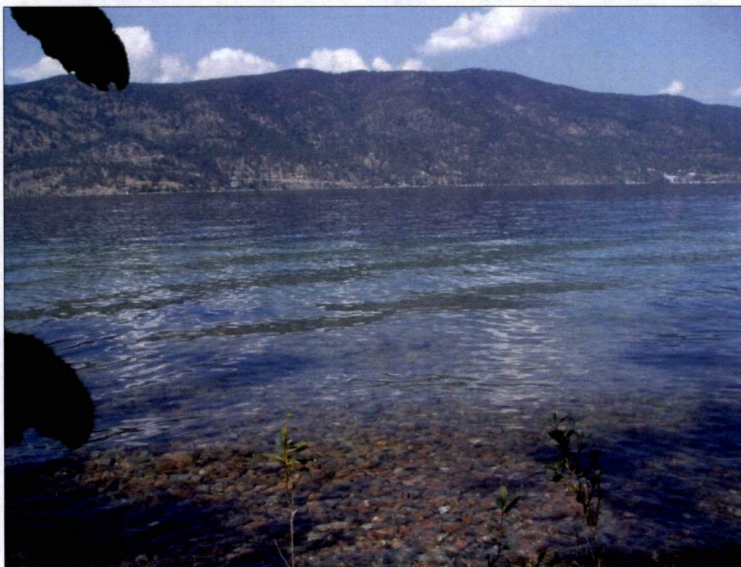
Looking out from shore along proposed dock alignment.

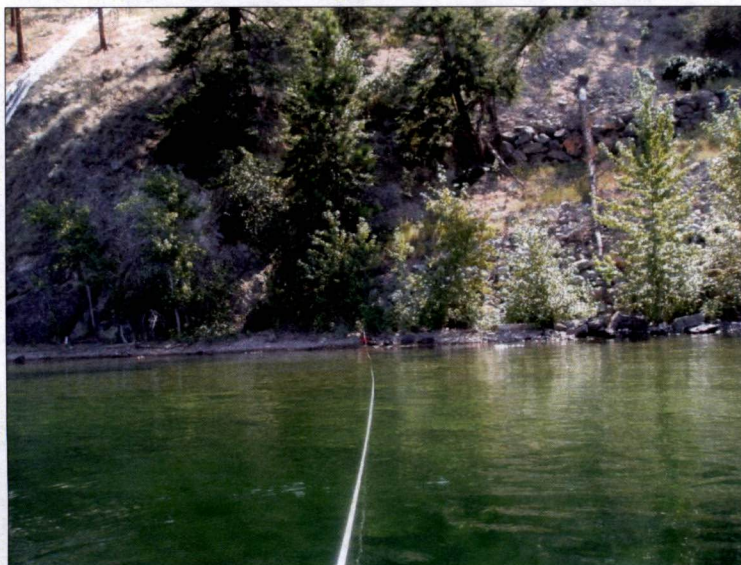
Looking in toward shore along proposed dock alignment.
