Re: **Addition to Private Dock at 61 Beachwood Road, RDCO, BC**
Lot 9, Plan 18400, DL 3795, ODYD - Environmental Assessment

The following letter report provides an environmental assessment of the proposed addition to your private dock at 61 Beachwood Road in the Regional District of Central Okanagan (RDCO) on the west side of Okanagan Lake near Fintry Landing.

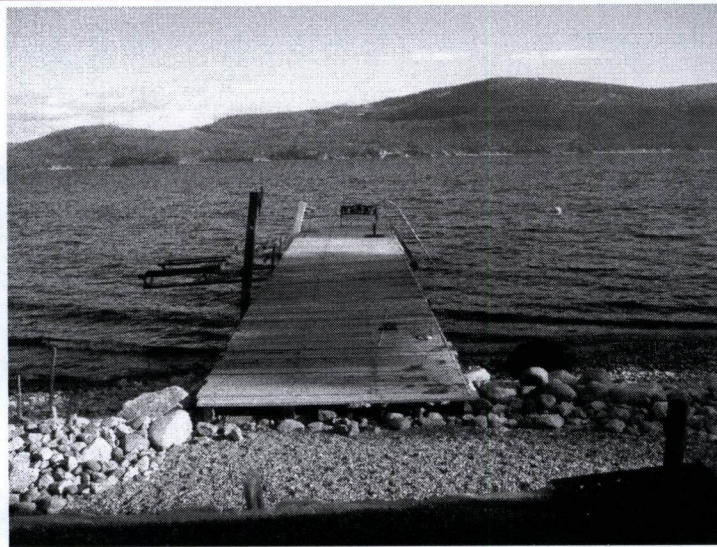
Photo 1.
Existing dock at 61 Beachwood
Road near Fintry, BC.
Nov 14/12

The project site is located on the west side of Okanagan Lake approximately 20 km southwest of Vernon, BC (Figure 1). The existing dock (Photo 1, Figure 2, Figure 3) is 19.5 m long × 3 m wide for a total area of 58.5 m². The dock addition will consist of extending the walkway by an additional 4.5 m and adding a 3 m wide × 8 m long el, supported on six piles, to the south (Figure 3). The dock area to be added, including a small angle between the walkway and el, will be approximately 37 m². Water depth under the dock addition will be greater than 0.8 m below the low water mark of 341.34 m, meeting the depth requirement where new dock construction can be wider than 1.5 m. An existing boat lift on the north side of the existing dock will be moved out along the new section of walkway, while an existing jet ski lift closer to shore on the north side of the dock will be moved out to the present boat lift location (Figure 3).

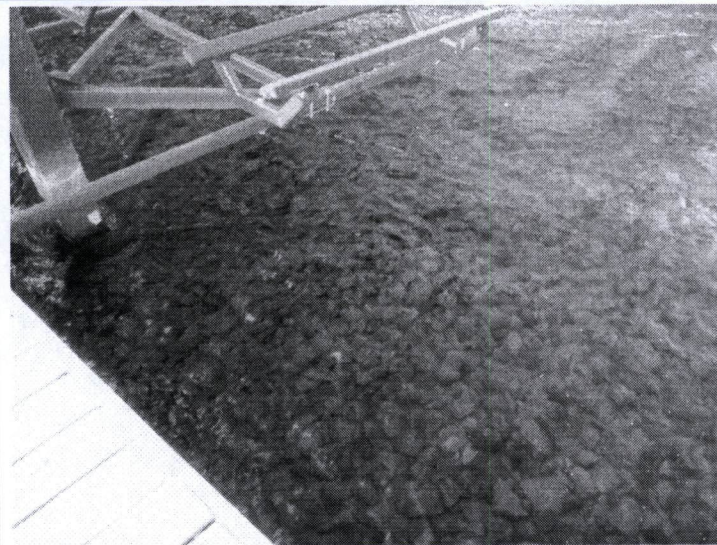
Photo 2.
Predominantly cobble substrate at
dock location.
Nov 14/12

The lake bottom at the dock location had a relatively constant slope of 9% out to 50 m from high water mark (HWM) (Table 1) (Figure 3 Section View). Substrate was a predominantly 8-15 cm cobble (Photo 2). Carpet to suppress aquatic plant growth covered the bottom around 19-20 m from HWM, while a mix of cobble, boulder, and sand with suspected Eurasian milfoil (*Myriophyllum spicatum*) were observed around 30 m out.

The site appears to have low to nil spawning potential for kokanee and whitefish because these shore spawning fish require rocky substrate with interstitial spaces to protect their eggs and newly-hatched offspring from predators and physical damage from waves. The cobble substrate at the dock site is either bedded on or embedded in fine gravel and sand, affording no such spaces for eggs to settle.

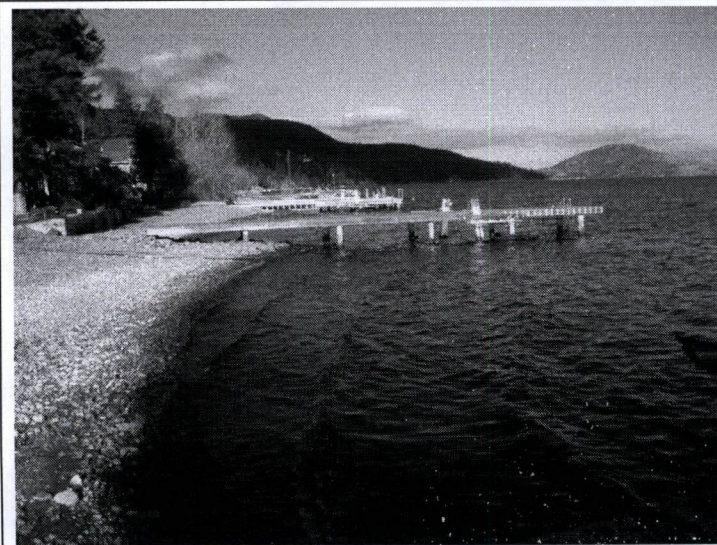
Photo 3.
Shoreline looking north from
proposed dock.
Nov 14/12

The shoreline at the dock site is a yellow zone (moderate value habitat) under the OLLP (Figure 4) based on historic kokanee sightings. There is a black zone (critical habitat) starting approximately 1.8 k south of the dock (Figure 4). Adjacent docks are located approximately 30 m north (Photo 3) and 30 m south (Photo 4).

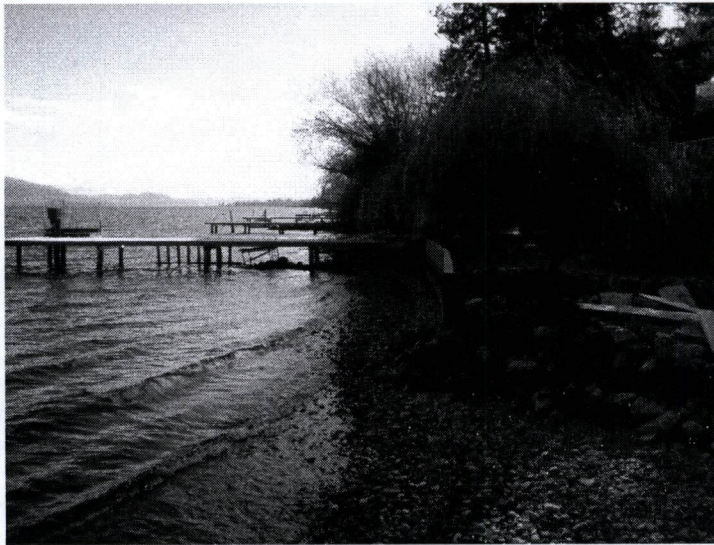
Photo 4.
Shoreline looking south from
proposed dock.
Nov 14/12

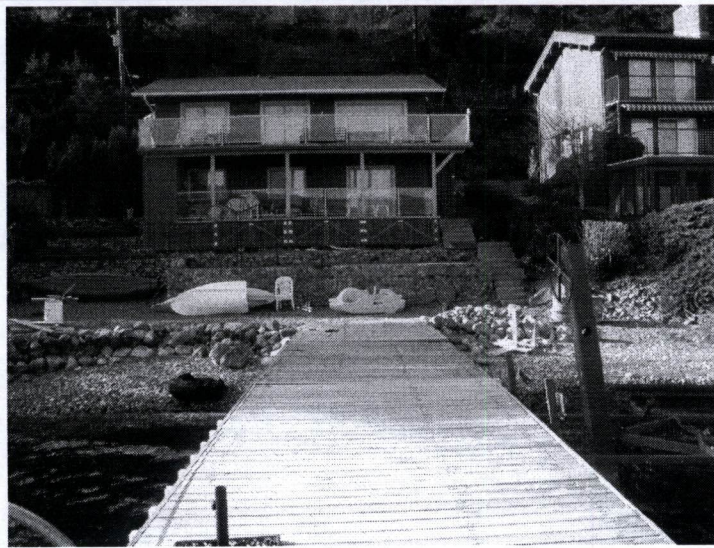
Photo 5.
View toward shore showing
limited riparian vegetation.
Nov 14/12

There was very little riparian vegetation in the vicinity of the proposed dock, with the landscaped yard consisting of rock, gravel, and synthetic turf (Photo 5). A few ornamental shrubs were present in rock terraces further back from the water.
