Qualified Professional Checklist for Foreshore Works - Okanagan LLFP

Project Name: **New Dock at Horseshoe Bay (P.I.D. 003-000-583) near Peachland, BC**
 Water Body: **Okanagan Lake** Proponent: **Rick Mervyn**

Project Description: Install 45 m long new dock with 27 m long aluminum bridge, light penetrating decking on entire dock, (including over potential shore spawning habitat), 16 small-diameter (15 cm) steel dock piles and 4 small-diameter boat lift piles (refer to attached Figure – Nexus Drawing FC12).

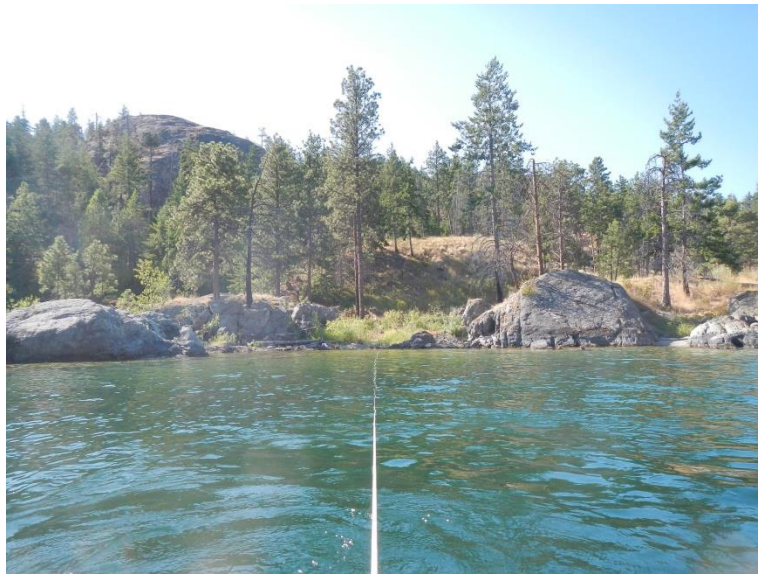
Photo 1.

| Have you ... | | Yes | No | N/A | Explain |
|--|---|---|---|---|--|
| | d) Sensitive Ecosystem Inventory? | X | | | Okanagan SEI Map 82E072 – mapped ecosystem is Coniferous Woodland (Photo 1) |
| 1.2 conducted any inventories to confirm presence/absence of fish, emergent vegetation and SAR or their habitats on site? | | X | | | site visit conducted August 19/15; substrate has shore spawning potential; no aquatic vegetation; riparian vegetation had scattered Ponderosa pine to 35 cm (Photo 1), with reed canary grass, cottonwood saplings, and rose at proposed dock origin (Photo 2) |

Looking toward shore along proposed dock alignment, showing riparian conditions and Coniferous Woodland forest.

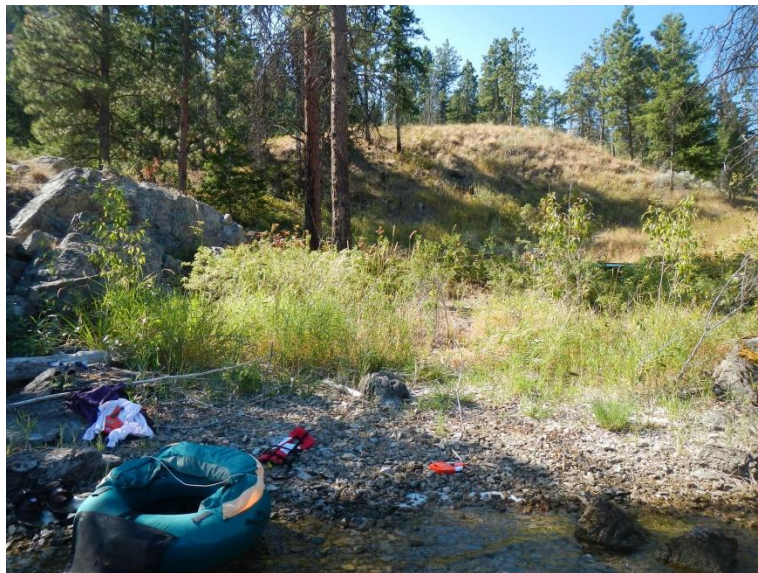
Photo 2.

| Have you ... | | Yes | No | N/A | Explain |
|--|---|---|---|---|---|
| 1.4 | evaluated and described local soil and foreshore substrate? | X | | | beach substrate 2-3 cm gravel (Photo 2), becoming subangular 4-5 cm toward low water mark, then varied mix of 2-30 cm cobble, boulder, subangular rock, and bedrock (Photo 3) |

Looking in at proposed dock origin, showing beach substrate, bedrock outcrop, and vegetation.

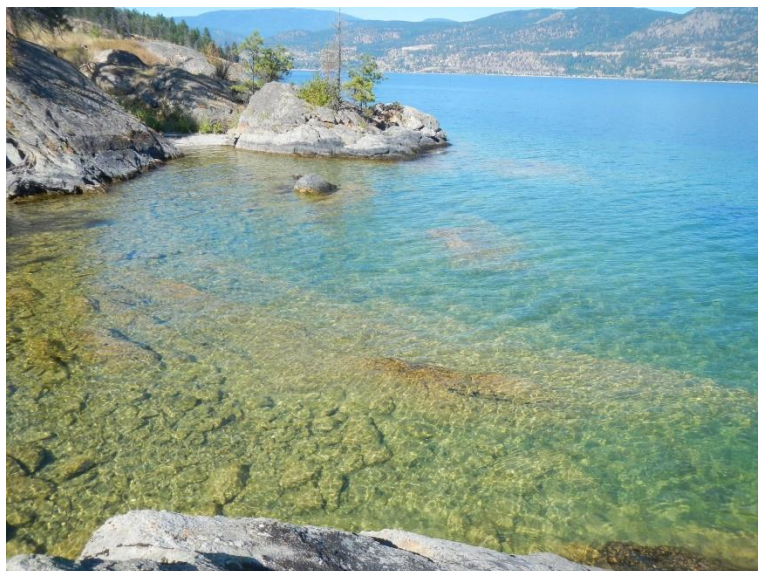
Photo 3.

Looking across east to west at proposed dock location, showing nearshore conditions including varied substrate of cobble, boulder, subangular rock, and bedrock.

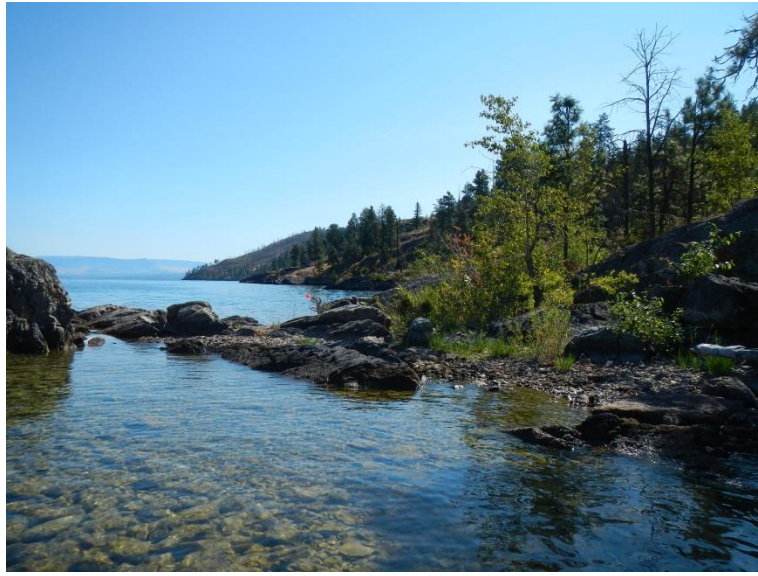
Photo 4.

| Have you ... | Yes | No | N/A | Explain |
|--|---|---|---|---|
| 2.9 maintained a 50 m lakeshore frontage between moorage structures on single lots? | X | | | no other existing docks in sight (Photo 4, Photo 5) |

Looking east from proposed dock location, showing absence of existing shoreline development.
