February 9, 2015

Re: Reservoir fillslope sign off.

Road section identification: Battani Creek reservoir fillslope.

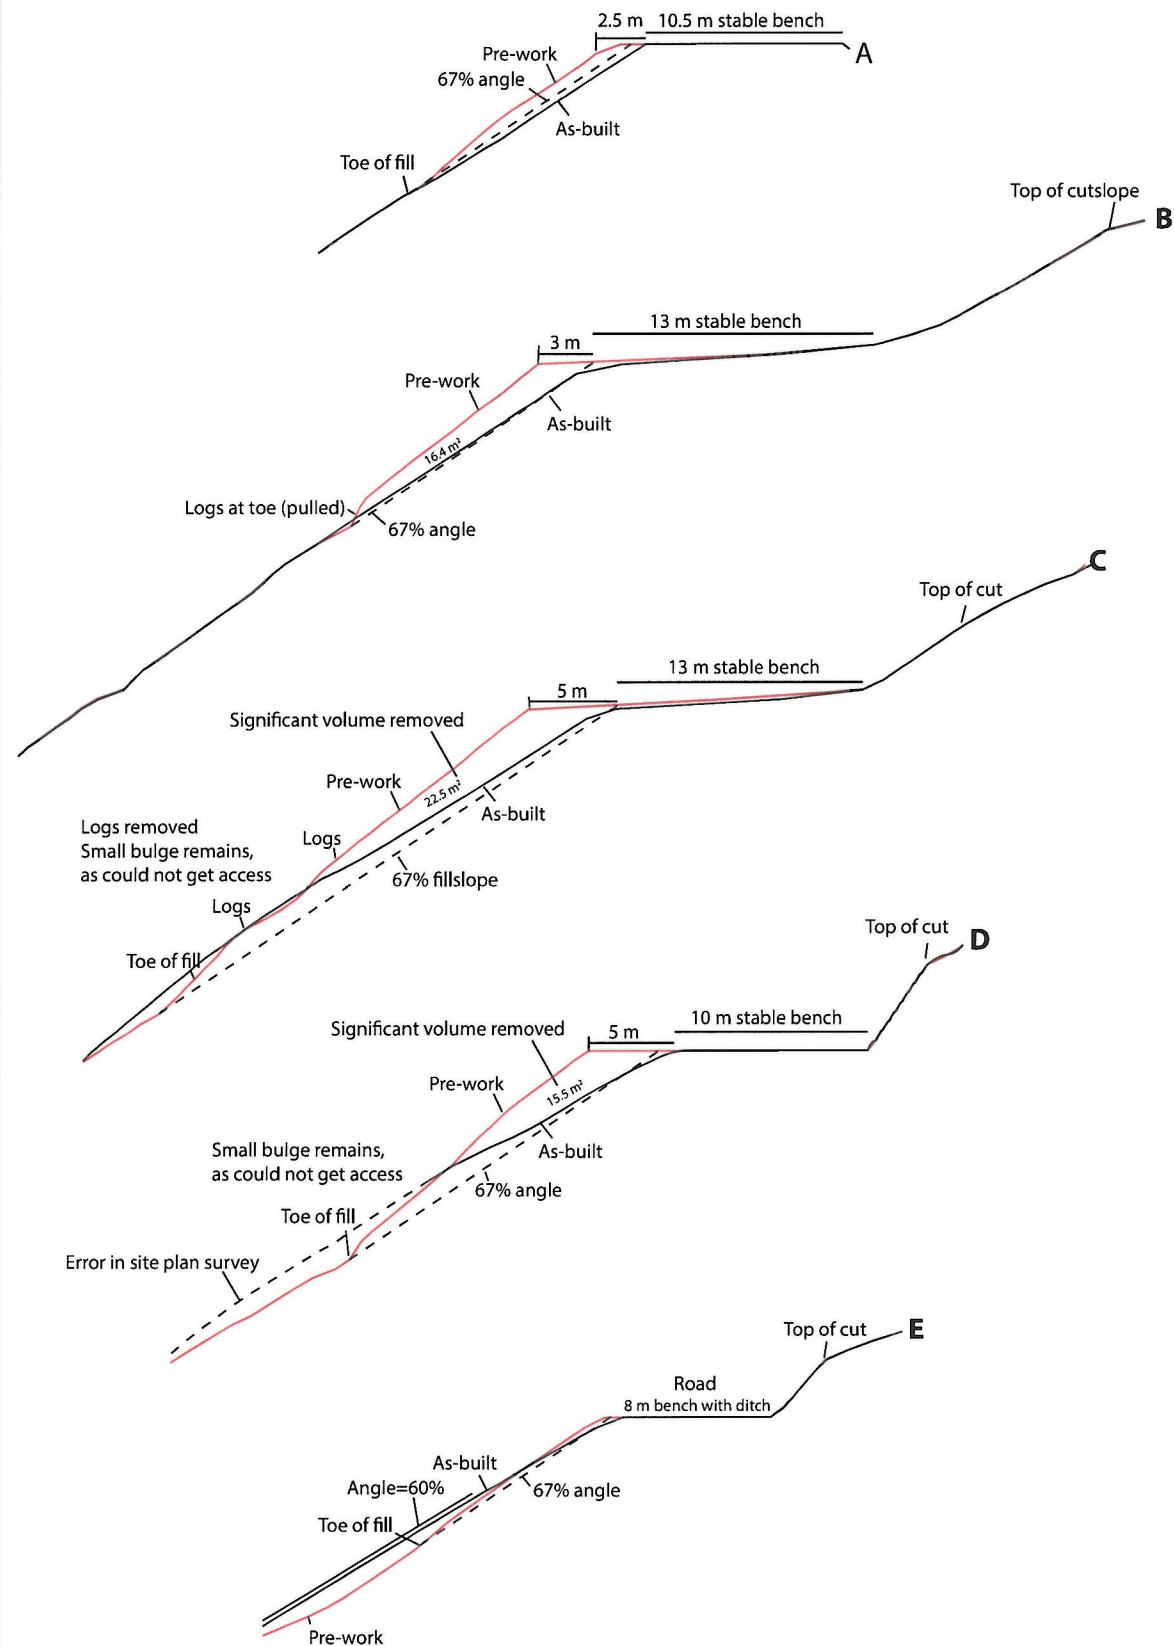
Site Plan by JCH Forestry

Pullback excess fill, from toe to pullback line, as marked, leaving 67% fillslope angle (approximately 500 m3 volume).

Test landing area to document extent of bedrock and depth of cover (not done to wet soils).

Armour reservoir and culvert outfalls (Done).

Assess design discharge and ensure outlet capacity (Done).
